MISSISSIPPI RIVER: STUDY OF ALTERNATIVES FOR
REHABILITATION OF LOCK AND D..(U) CORPS OF ENGINEERS ST
PAUL MN ST PAUL DISTRICT APR 76

MISSISSIPPI RIVER

GEOLOGY, FOUNDATIONS AND SOILS INVESTIGATIONS

GEOLOGY AND FOUNDATION EXPLORATION

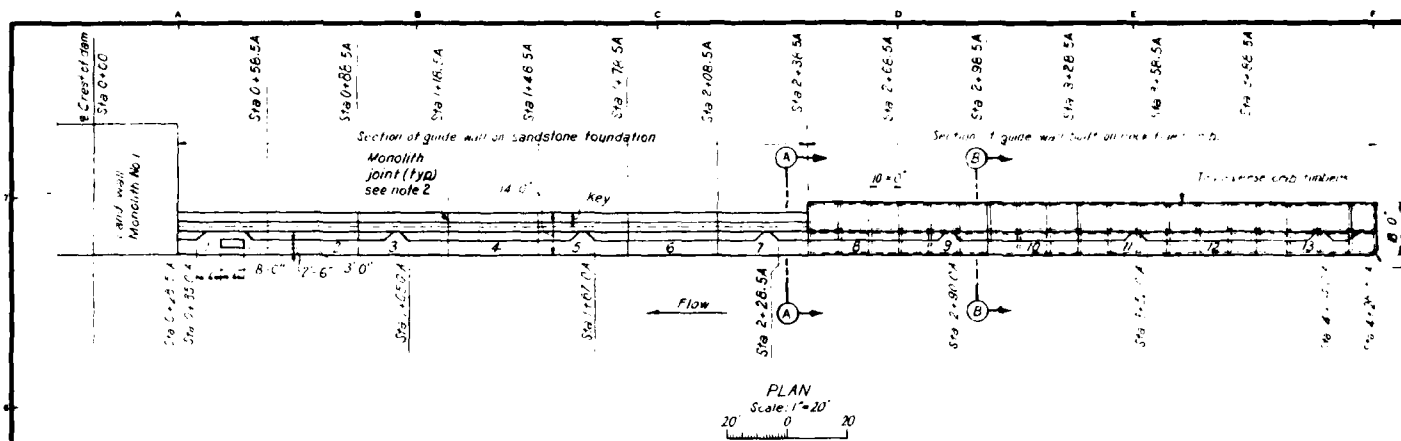
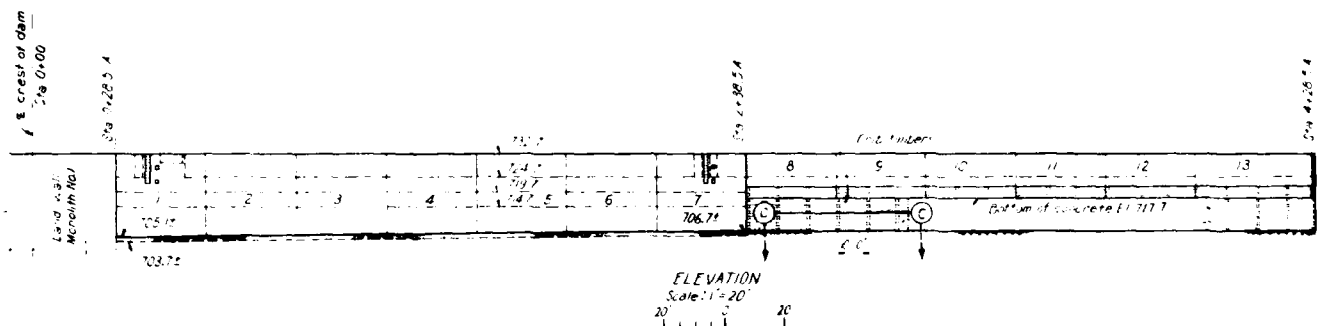
TABULATION OF WALL MOVEMENTS
See sections A-A & B-B

Station	1934-1963 Recorded max horizontal movement	1936-1963 Recorded max vertical movement	1950-1963 Recorded max vertical deviation
4+23.6A	0.14 West	0.02 upward	0.45 East
1+89.0A	0.12 West	0.02 upward	0.18 East
0+71.0A	0.12 West	0.02 upward	0.09 East

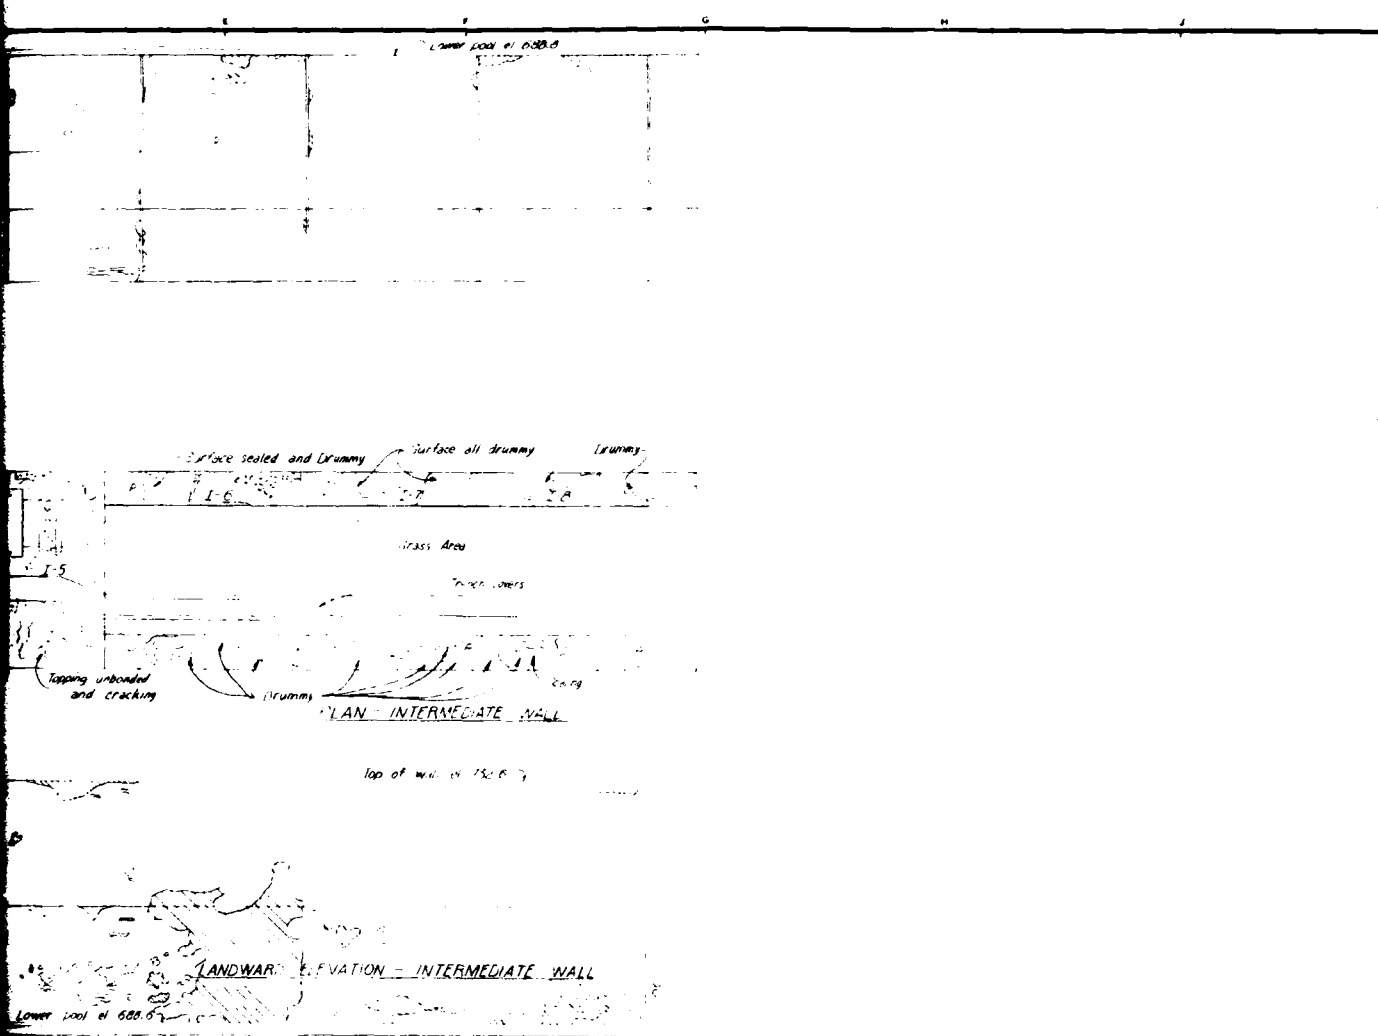
<p>Severe cracking on top surface. Moderate to severe longitudinal cracking at water and lower portion of the river side and local areas of wall side wall.</p> <p>Slight spalling along vertical joints and slight to moderate spalling on lower portion of landlock wall. Slight scaling on all surface. Top surface heavy over most areas. 50% top surface repaired.</p> <p>See above Vertical joints tight.</p>	<p>Minor cracks on lower portion of wall at both sides.</p> <p>Slight spalling at bottom of wall on river side & along vertical joints. Severe spalling on most areas of landlock wall. Slight to moderate scaling on walls. Top surface drummy and moderate scaling. 60% top surface repaired.</p> <p>See above Vertical joints tight.</p>	<p>Minor cracks at upper edge of river side of wall and in local areas of landlock side wall.</p> <p>Slight spalling along vertical joints. Slight spalling on lower portion of wall on landlock side. Slight scaling on walls. Top surface drummy. 50% repaired.</p> <p>See above Vertical joints tight.</p>	<p>Drumming on top of wall. Minor cracks at lower portion of wall on landlock side.</p> <p>Slight wall up at the lower landlock side wall. Moderate to severe spalling on portions of walls above waterline. Slight scaling on walls. Top surface heavy over most areas. 50% top surface repaired. 50% top surface repaired.</p> <p>See above Vertical joints tight.</p>

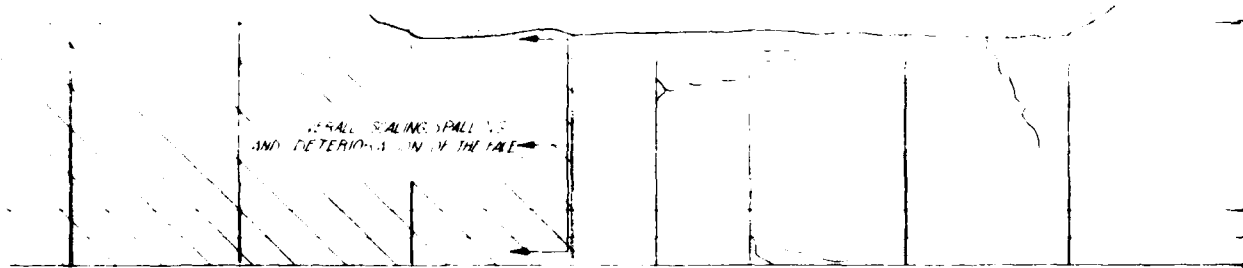
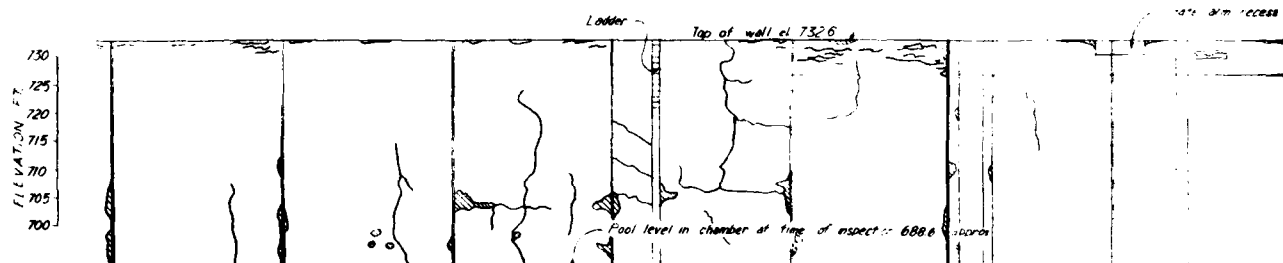
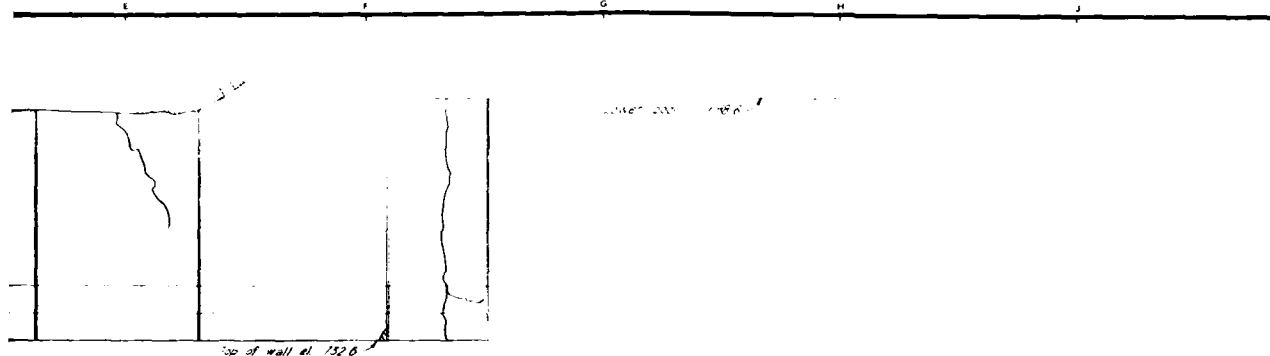
PLAN OF RIVERWARD WALL

MONOLITH NO.		14	15	16	17	18	19	20
CONCRETE CONDITION								
CRACKING		Minor to moderate longitudinal cracking at top of riverlock wall. Vertical crack in riverlock wall. Minor random cracking in local areas of top surface.	Minor longitudinal cracking at top of riverlock wall. Vertical crack in riverlock wall.	Minor longitudinal cracking at top of riverlock wall. Several vertical cracks in riverlock wall.	Vertical and horizontal cracking in riverlock wall. Minor longitudinal cracks.	Severe longitudinal cracking at top of riverlock wall. Vertical crack in riverlock wall.	Some vertical cracks.	Minor longitudinal cracking at top of riverlock wall.
SCALING AND SPALLING		Severe scaling on river wall face and top of river wall. Minor scaling on top of riverlock wall.	Severe scaling on river wall face and top of river wall. Moderate weathering and scaling on top of riverlock wall.	Several scaling on river wall face and top of river wall. Minor surface scaling on top and face of riverlock wall.	Severe scaling on top of riverwall. Riverwall face weathered. Minor scaling and weathering on top, and moderate scaling & spalling on face of riverlock wall.	Moderate scaling of top surface. Minor spalling and scaling on riverlock wall.	Minor weathering on top surface, some scaling along edges of riverlock wall.	Minor spalling along vertical edges. Moderate scaling on top surface.

JOINTS		Vertical joints between mono #13 and mono #14. Open 3/8" at top.	Minor spalling along vertical joints in riverlock wall. Vertical joints tight.	Vertical joint between mono #16 and mono #17. Open 3/8" at top.	Vertical joint between mono #18 and mono #17. Open 3/8" at top.	Vertical joints tight.	Vertical joints tight. Leaching from horizontal construction joints on riverwall.	Vertical joints tight. Leaching from horizontal construction joints on riverwall.
OTHER		Moderate leaching from longitudinal cracks at top of riverlock wall.	Slight leaching from top of riverlock wall.	Minor leaching from longitudinal cracks at top of riverlock wall.	Minor to moderate leaching from longitudinal cracks and from vertical cracks in riverlock wall.	Severe leaching from longitudinal cracking to moderate along vertical cracks.	Minor leaching from vertical cracks.	Minor leaching from longitudinal cracks.
